Proposed Large-scale Residential Development,  
Sarsfield Road, Wilton, Co. Cork

Quality Audit Report

January 2025

<b>Client</b>	Land Development Agency
<b>Project Title</b>	Proposed LRD, Sarsfield Road, Wilton, Co. Cork
<b>Document Title</b>	Quality Audit Report
<b>Document No.</b>	24112TT_MHL-Doc01-QAR_Quality Audit

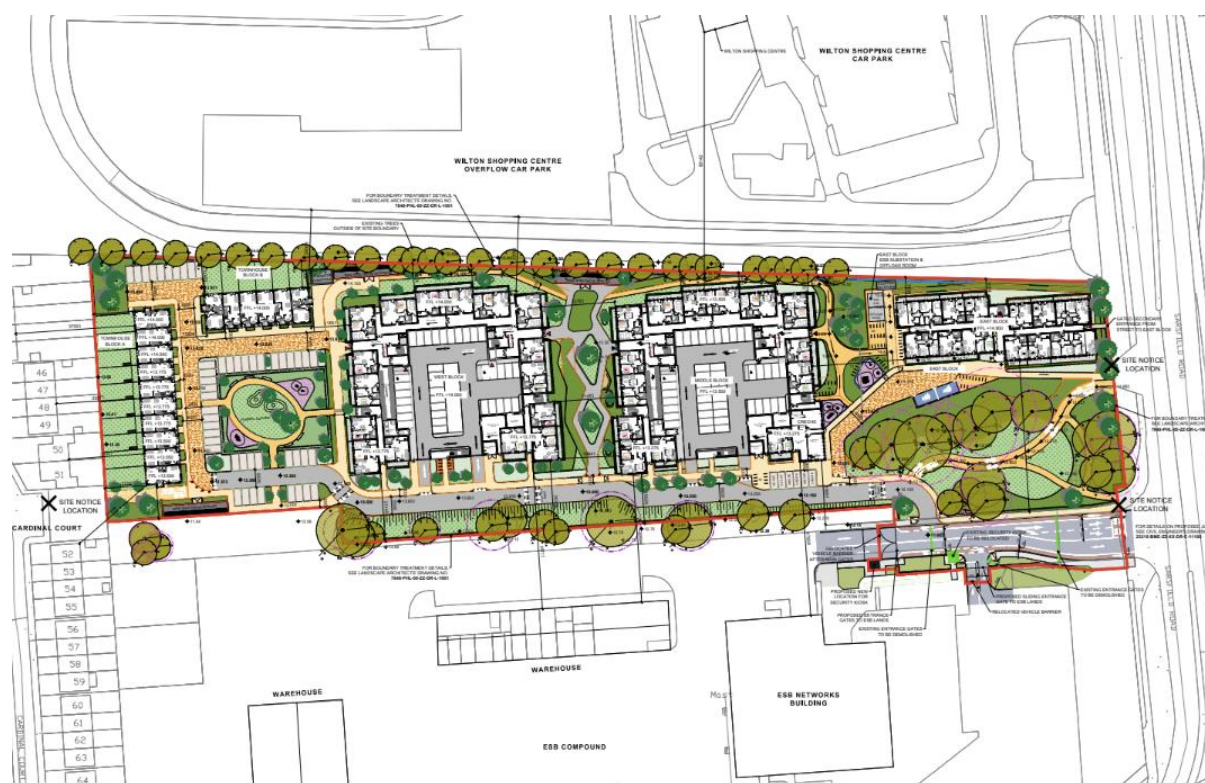
**Figure 1.1: Proposed Revised Development Layout (c: Reddy Architecture + Urbanism)**

The scheme to be submitted for planning approval is shown in Figure 1, Site Plan.

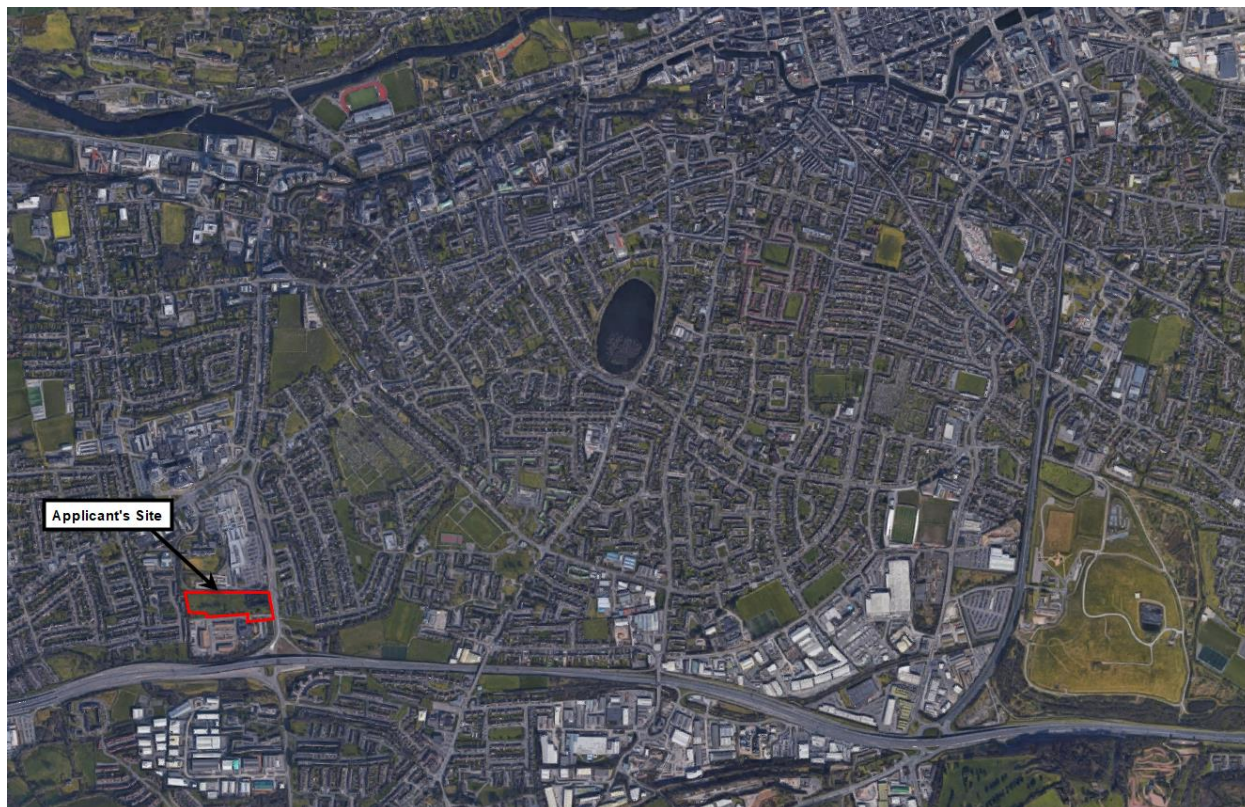
**Figure 2.1 Proposed Site Location**

Figure 2.1 highlights the location of the site in Wilton in close proximity to the R641, and Cork City Centre. The R641, which will be the primary access route for users of the proposed development, is directly east of the site. There are high quality pedestrian and cycle facilities currently provided on the access road to ESB Networks and on Sarsfield Road. Footpaths and raised cycle tracks, of approximate width 2m, are provided northbound along the R641 for 500m as far as The Wilton Roundabout. In the southerly direction of Sarsfield Road Roundabout, a shared pedestrian/cycle path is provided through the roundabout as far as Richmond Residential Estate (circa. 350m from the proposed development).

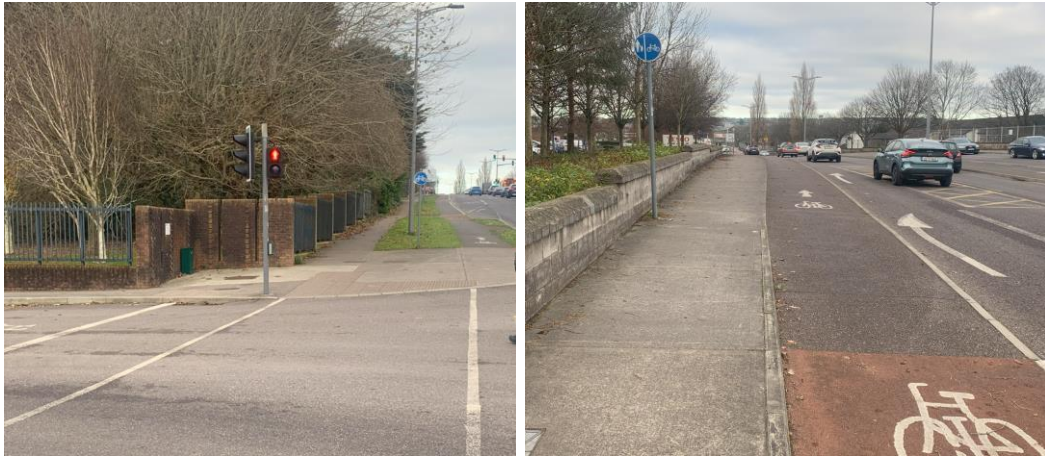
**Figure 3.3: Pedestrian/Cycle Infrastructure along R641 towards Wilton Roundabout**

High quality pedestrian and cycle facilities are available for the area surrounding the proposed development. Footpaths (circa. 2m wide) are available north along Sarsfield Road as far as nearby bus stops and The Wilton Roundabout. Segregated, raised cycle tracks (circa. 1.75m wide) are also available on either side of the road, northbound from the proposed development. Signal controlled crossings are provided at the Wilton Shopping Centre access junction and in close proximity to the bus stops either side of the R641.

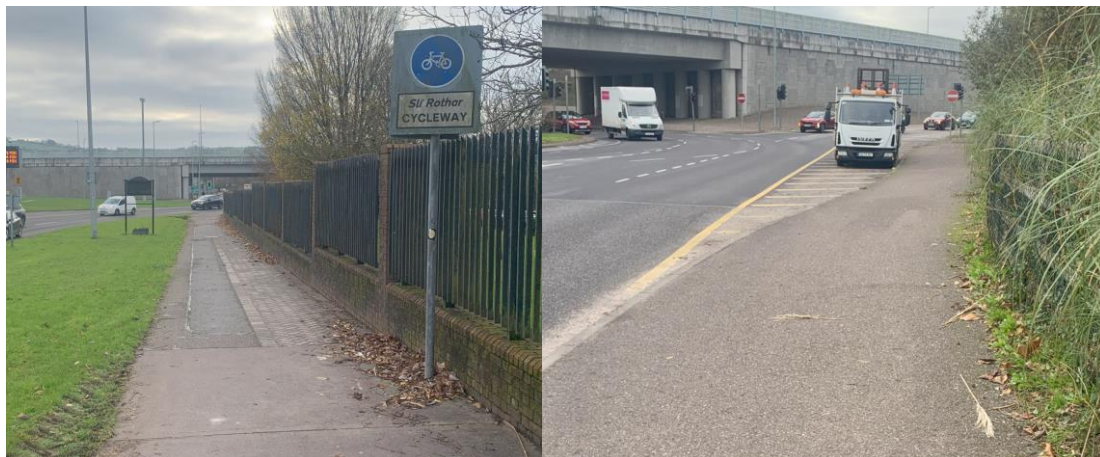
**Figure 3.5: Pedestrian/Cycle Infrastructure along R641 towards Sarsfield Road Roundabout**

To the south of the proposed development, a shared cycle/pedestrian surface is available connecting to The Sarsfield Road Roundabout and an existing greenway which provides

connectivity to The Bandon Road Roundabout and the wider Bishopstown area. Signal controlled crossings are provided at Sarsfield Road Roundabout to allow for the safe passage of pedestrians/cyclists through the roundabout.

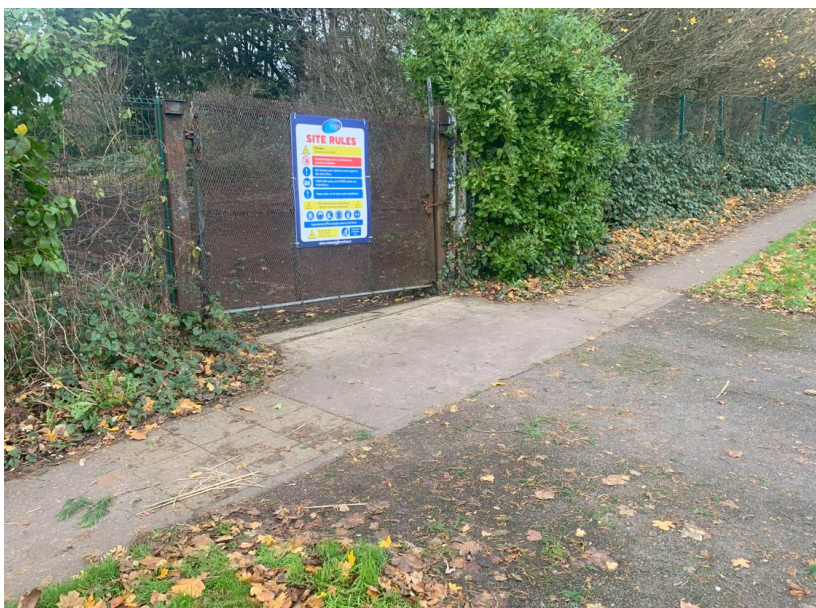
**Figure 3.7: Location of proposed shared Pedestrian/Cycle Access**

The proposed development includes pedestrian access points on the eastern boundary of the site. One of these access points is also for the provision of cyclists off Sarsfield Road.

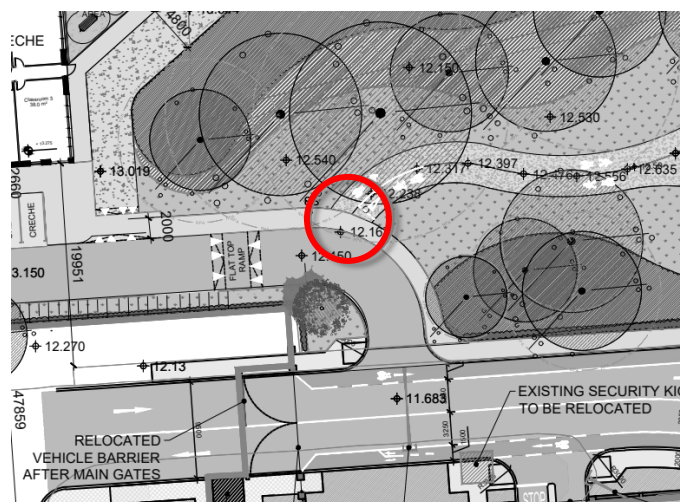
No provision for cyclists to exit the shared surface onto the adjoining internal road. This may result in cyclists continuing along the footpath or entering the carriageway off the raised kerb at an unsafe location. Both of these scenarios could result in a collision between a cyclist and a pedestrian or a cyclist and a moving vehicle.

Provide a ramped exit to/from the shared surface for cyclists to ensure safe connectivity to the existing cycle lane along the ESB Access Road, with appropriate signage, in accordance with the relevant design standards.

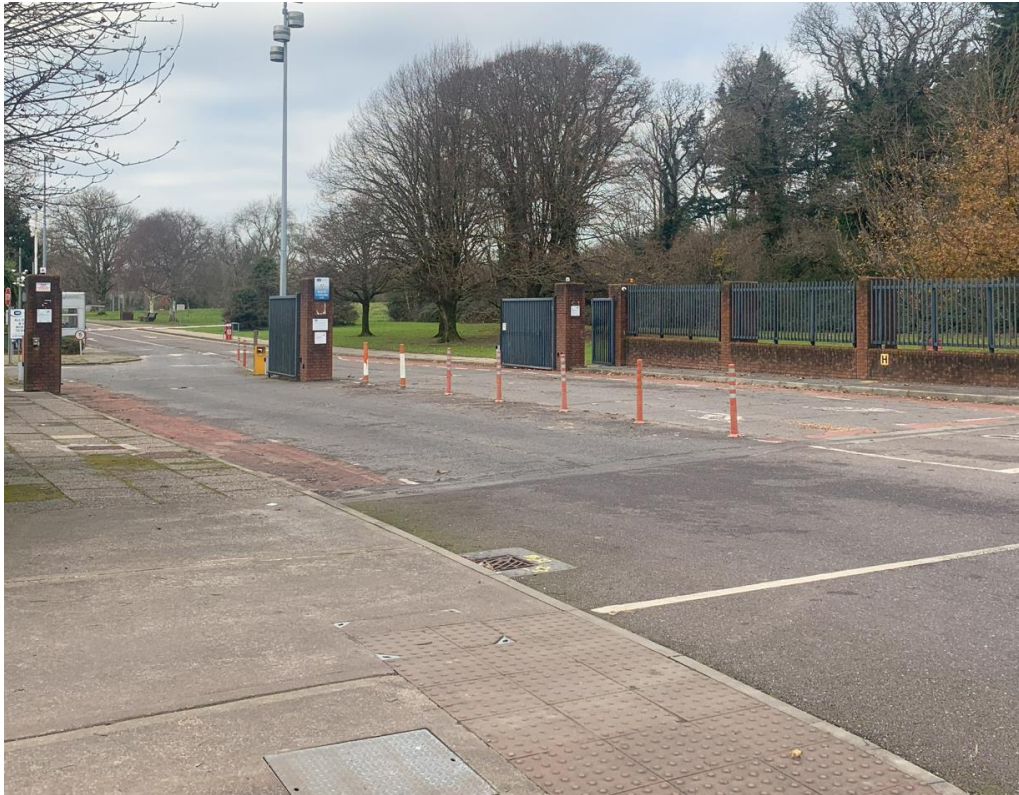
**Photo 1: Approximate Location of Development Entrance Junction**

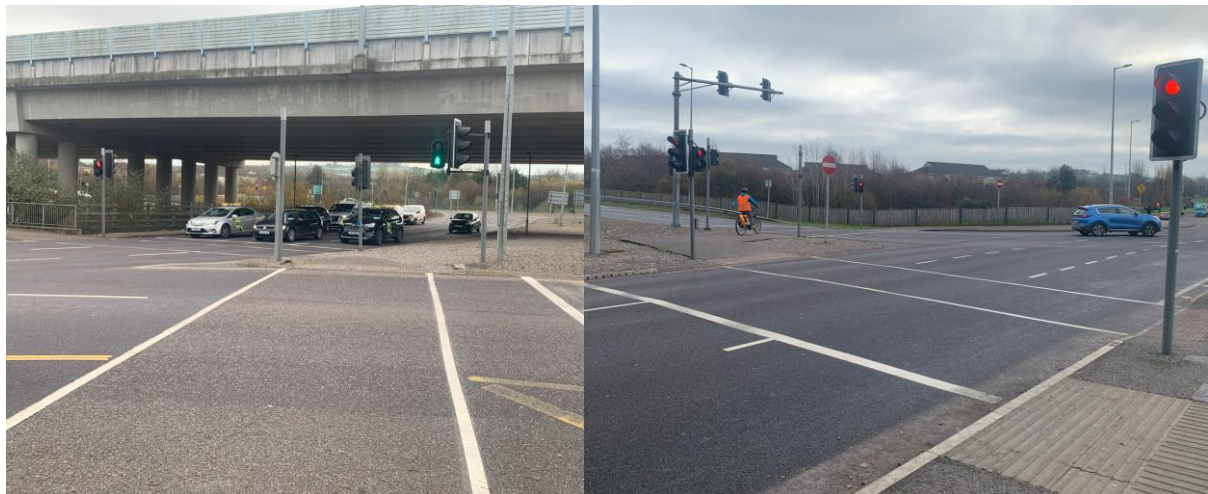
**Photo 4: Controlled Pedestrian Crossings at Sarsfield Road Roundabout**

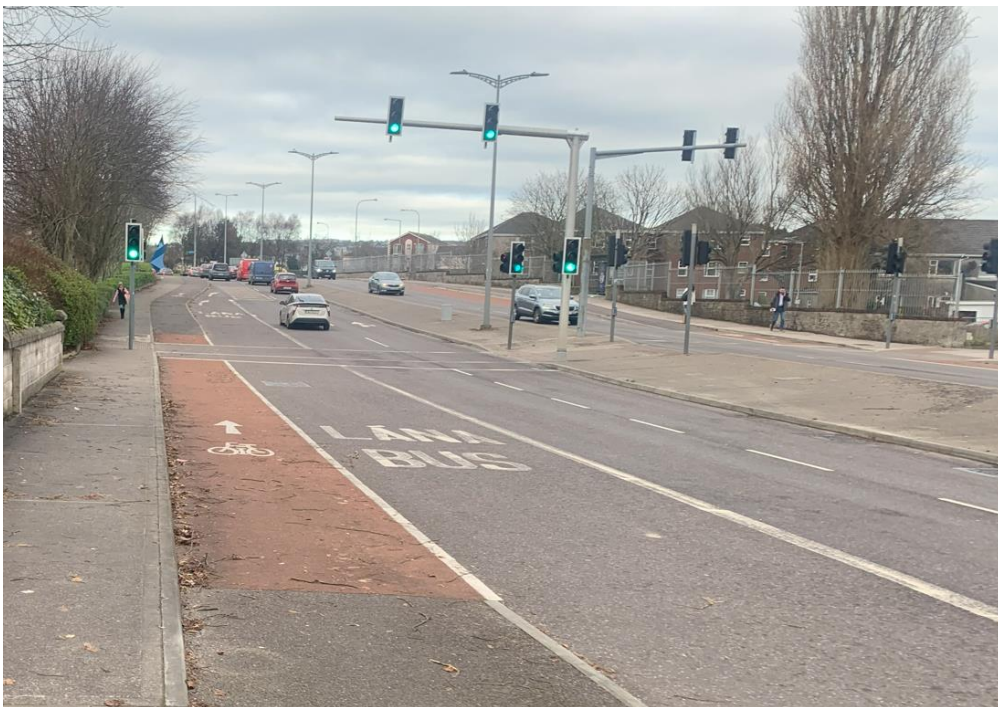
**Photo 6: Controlled Pedestrian Crossing to Bus Stops**
